**REPORT  
ON  
LAND CAPABILITY ASSESSMENT**

**PROPOSED DEVELOPMENT  
WESTERN SYDNEY PARKLANDS**

*Prepared for*  
**LANDCOM**

**PROJECT 40465  
JANUARY 2006**

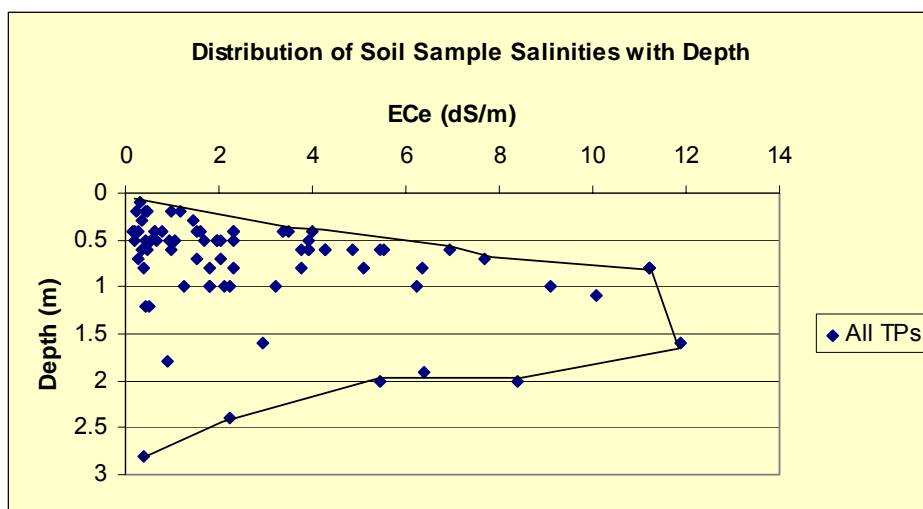
**Figure 1 - Distribution of Soil Sample Salinities with Depth**

The implication of these results, to the extent that the 76 test pit samples are representative of the study area, is that non-saline to moderately saline conditions can be expected throughout the study area, with only minor occurrences of very saline conditions. These results are, however, dominated by salinity measurements within the upper 1 m of soils, as indicated by the salinity-depth scattergram shown in Figure 1, showing all measurements from all test pits, together with an overall envelope.

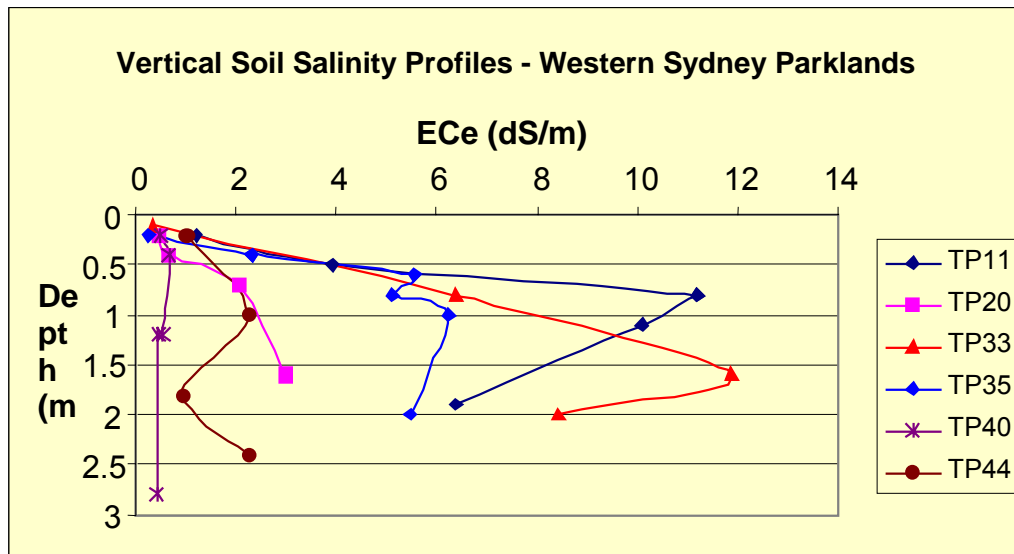
Figure 2 - Vertical Soil Salinity Profiles

At six locations (selected on the basis of initial apparent conductivity results to cover the full range of salinities within the area), test pits were sampled at several depths to a maximum of 2.8 m below ground surface. This enabled the construction of vertical soil salinity profiles (see Figure 2).

From these profiles it is inferred that where soils become moderately or very saline, these salinities are reached in the 0.5 – 2.0 m depth zone, corresponding in general to the B soil horizon. A number of test pits were sampled at the top of this horizon, however the distribution of salinities derived from test pit samples alone is expected to slightly underestimate salinities throughout the greater depth range of urban development.

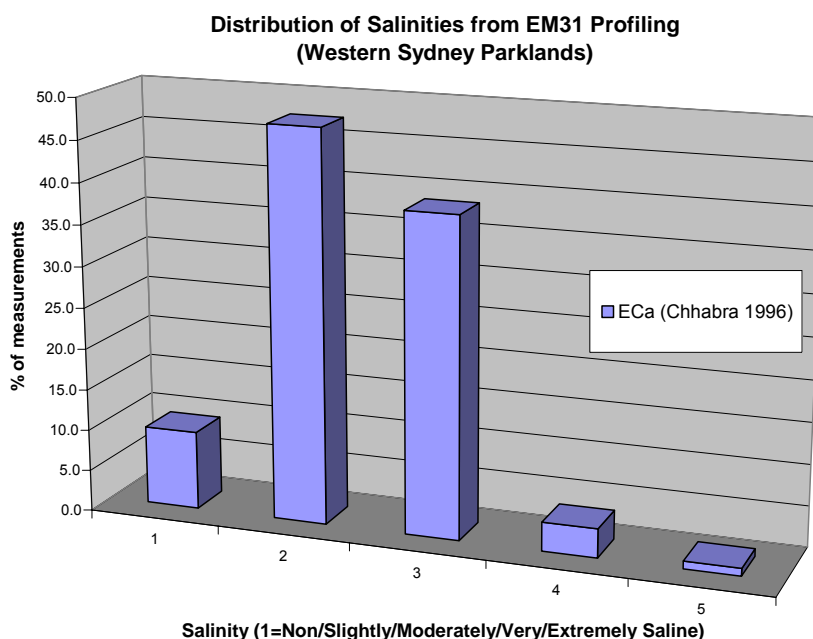
**Figure 3: Distribution of Salinities from EM 31 Profiling**

The histogram and table below show that of the 42 000 corrected and filtered apparent conductivity measurements over the study area, 57% fall in the non-saline to slightly saline classes of Chhabra (1996), with 39% in the moderately saline class and 4% in the very to extremely saline classes.

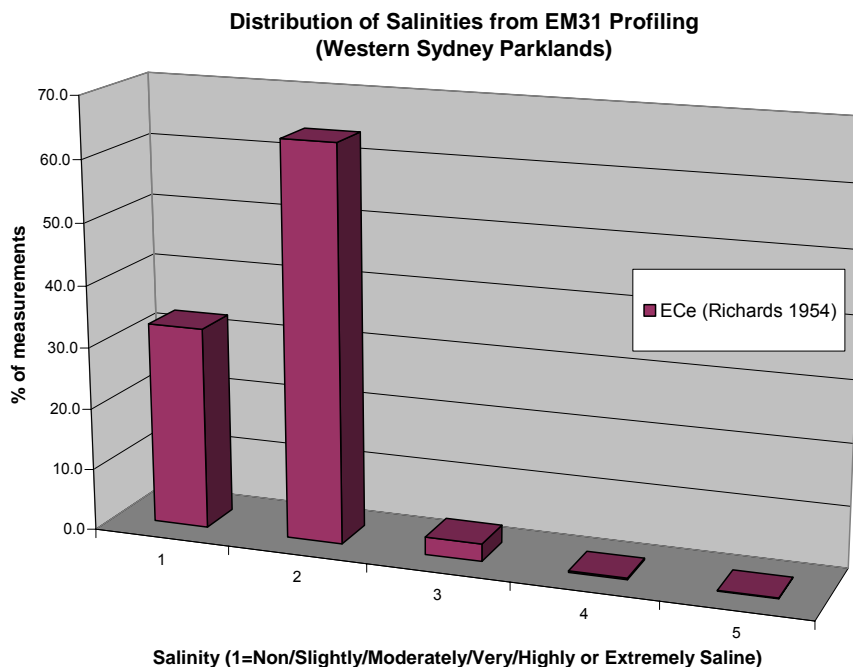
**Figure 4: Distribution of Salinities**

The factor was applied to all data, which was then re-gridded for presentation as an apparent salinity image (Drawing 7) with a continuous colour spectral scale in dS/m, based on the Richards (1954, Ref 9) classification scheme. The histogram and table below show that of the re-scaled data points, 97% fall in the non-saline to slightly saline classes of Richards, and 3% fall in the moderately saline class.
